North Ambergris Caye Road Assessment

For San Pedro Town Council

12 page report - North of Bridge assessed Sept 5, 2021

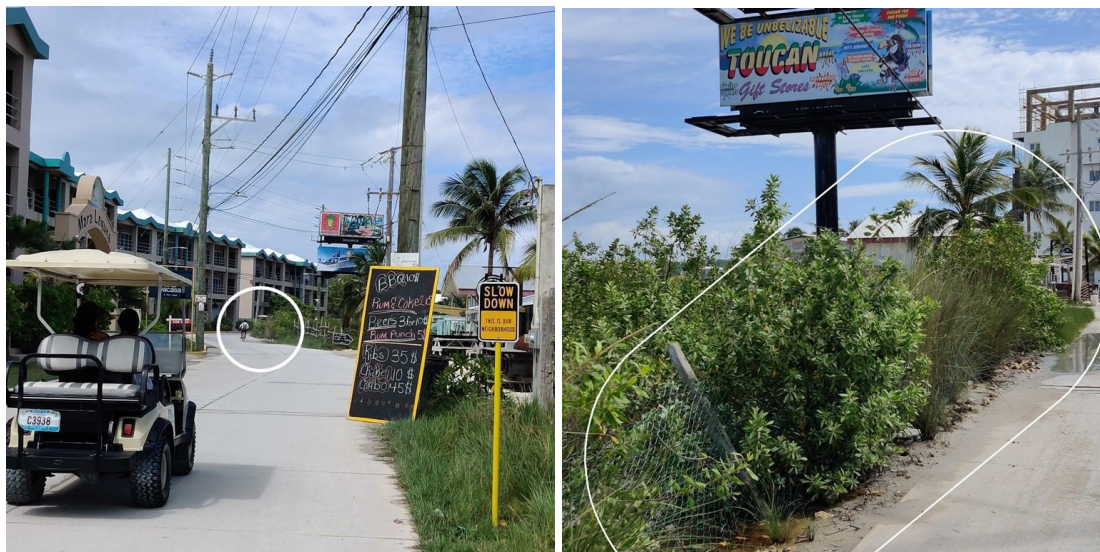
Area 1: Severity - 4

Location - Mara Laguna.

Problem - Blind corner.

Recommendation - Machete and clear 10 ft from the road of vegetation starting at the Farmhouse entry till well after the corner.

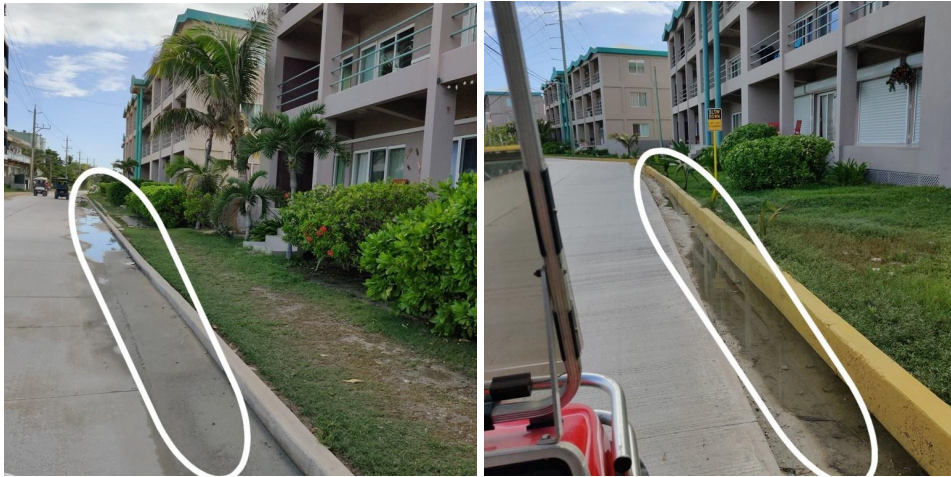
Area 2: Severity - 3

Location - Mara Laguna.

Problem - Drainage hazards causing accidents.

Recommendation - Fill without compromising their purpose.

Use coarse sand glass mulch from San Pedro Recycling or pea gravel.

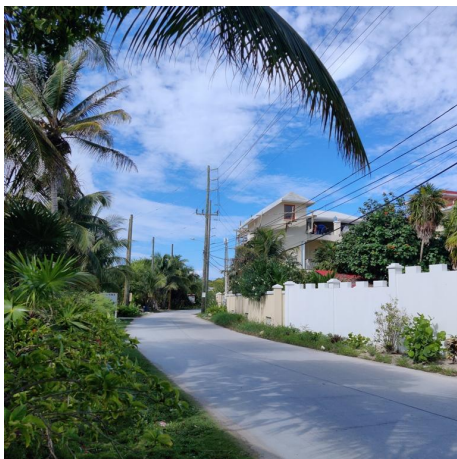
Area 3: Severity - 2

Location - Castle House.

Problem - Blind corner and no safe pedestrian walking area.

Recommendation - Sidewalk. The eastside of the entire north road from the bridge past Grand Caribe should be a designated walkway, paved or not, should be cleared and kept clear.

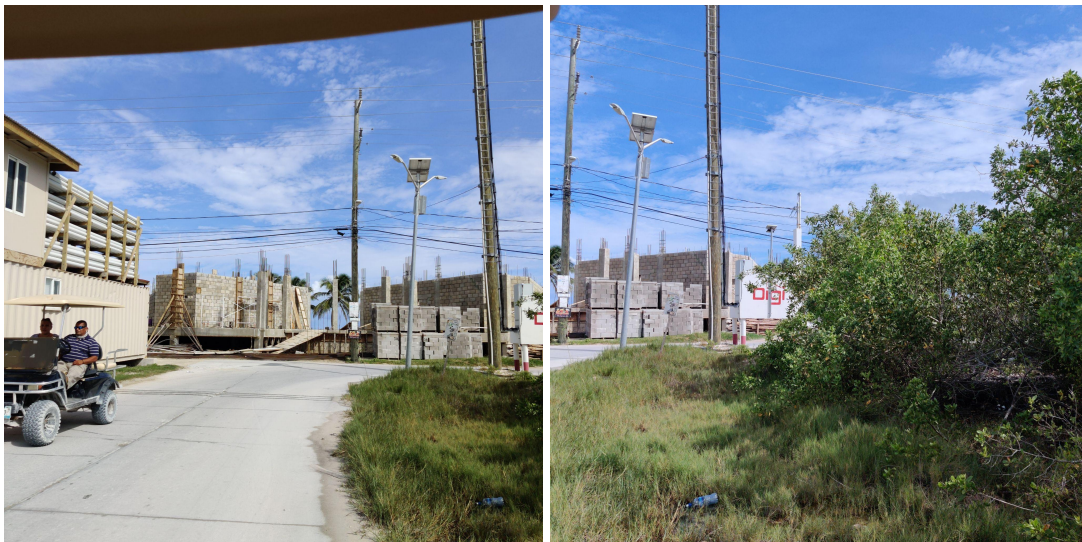
Area 4: Severity - 2 or 3

Location - Just south of Crocs old North Ambergris Police Station area.

Problem - Blind corner.

Recommendation - Vegetation trim 10 foot minimum inside corner west side of the road, should be more.

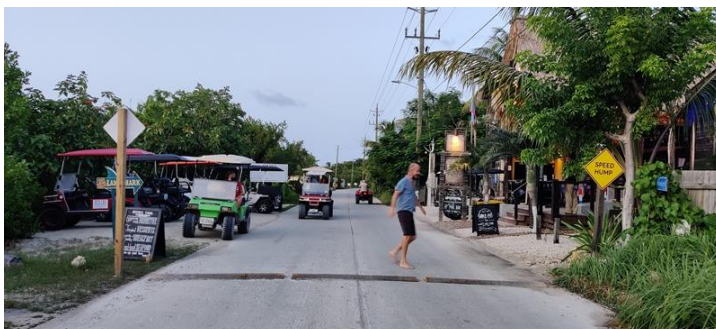
Area 5: Severity - 3

Location - Pur

Problem - Wrong kind of speed bumps and location. Narrow roadway forces all pedestrians, animals, etc. onto the road, no walkway along the road, especially Eastside.

Recommendation - Crosswalk style cement speed bump that provides a safer walkway from parking to the restaurant/hotel (move speed bump to the entrance of PUR walkway).

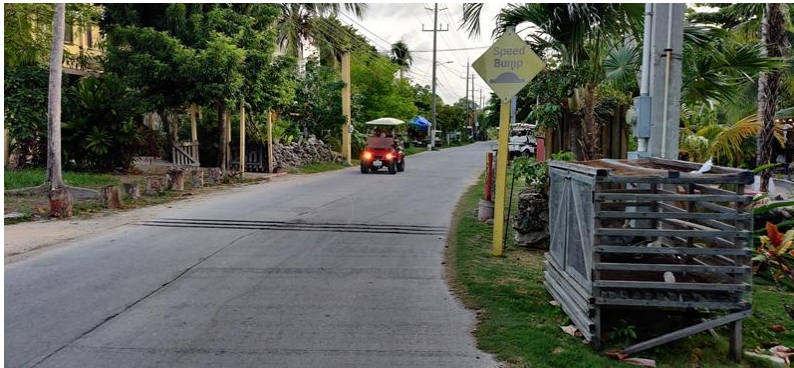
Area 6: Severity - 1

Location - Just north of Truck Stop

Problem - Sign and no speed bump.

Recommendation - Take sign down.

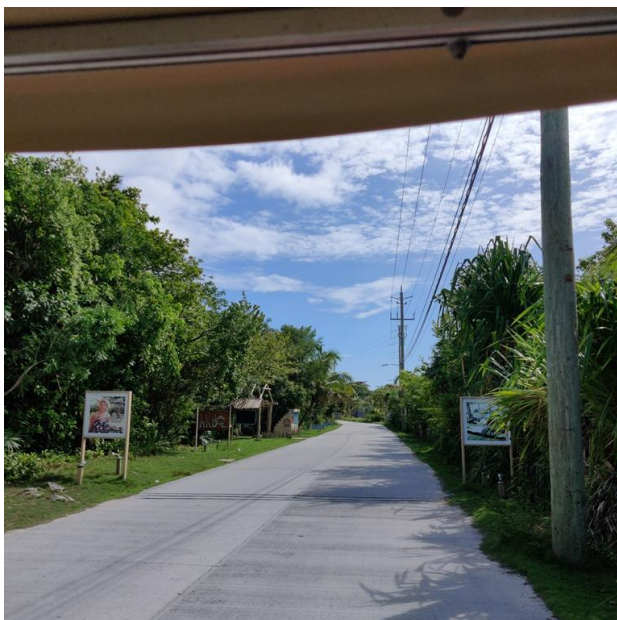
Area 7: Severity - 1

Location - South of Ak'bol

Problem - Blind corner, no pedestrian walk.

Recommendation - Clear walkway along east side of the road.

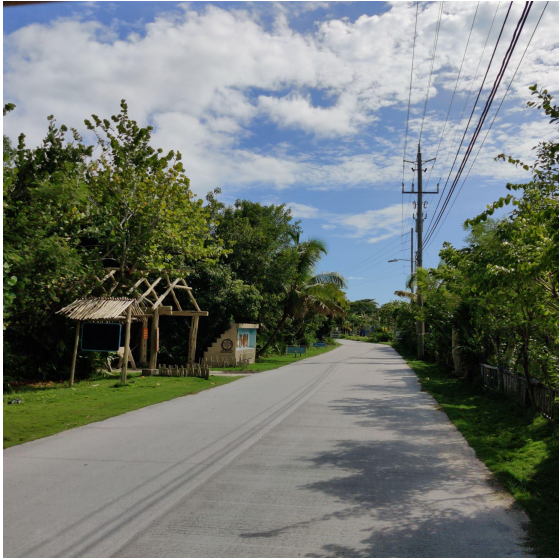
Area 8: Severity - 1

Location - North of Ak'bol

Problem - Needs proper speed bump with standardised signage.
Or Walkway along the roadside.

Recommendation - Make this multi functional by adding
sidewalks and a crosswalk speed bump.

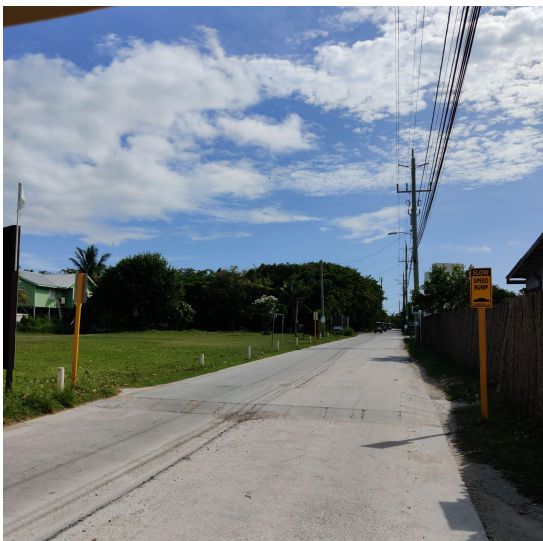
Area 9: Severity - 1

Location - Grand Caribe Problem - Better lighting and speed
bump markings. Recommendation - Stain or paint and add
adequate lighting.

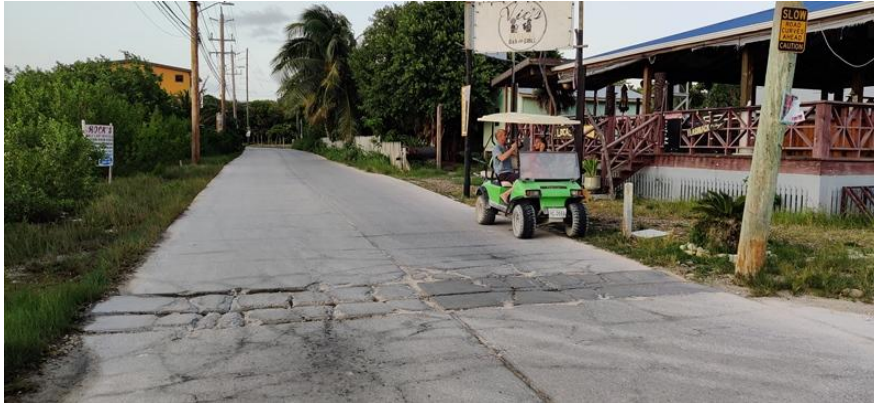
Area 10: Severity - 3

Location - Vics Karaoke Bar

Problem - Broken road

Recommendation - Full area needs restoration.

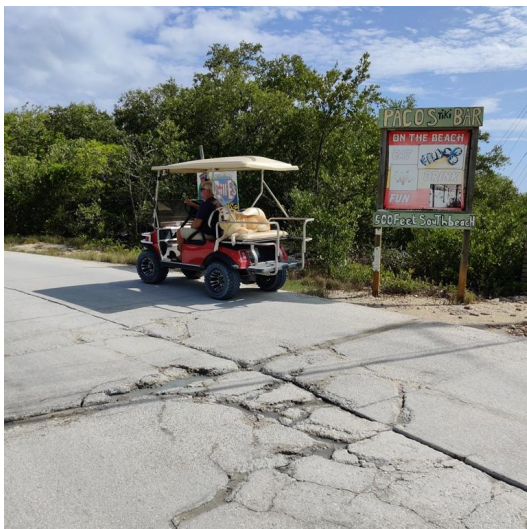
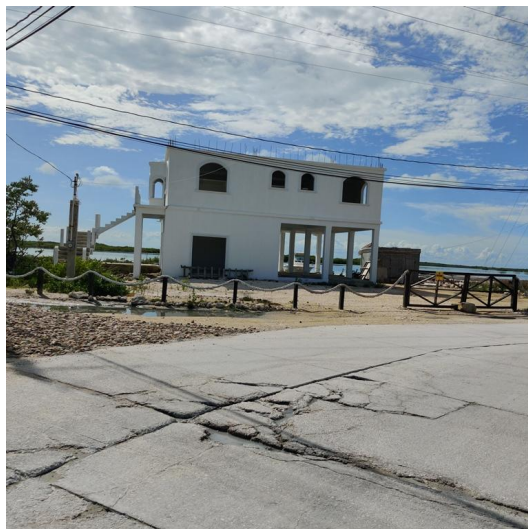
Area 11: Severity - 4

Location - Anglers Cove

Problem - Damaged road forcing traffic to the wrong side of the road.

Recommendation - Replace road sections.

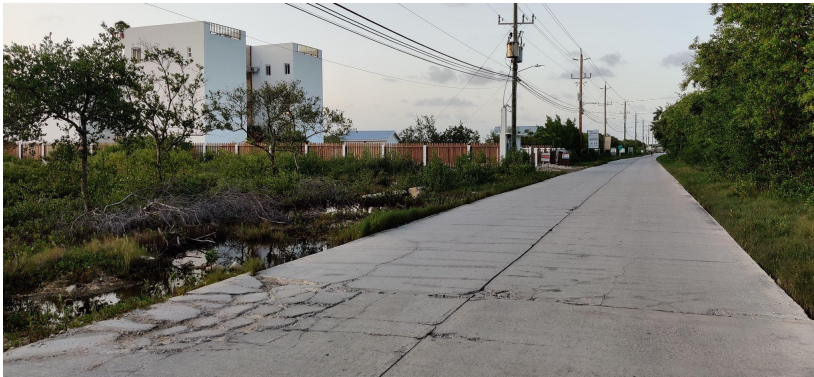
Area 12: Severity - 4

Location - Just north of Anglers Cove.

Problem - Damaged road forcing traffic to the wrong side of the road.

Recommendation - Replace road sections.

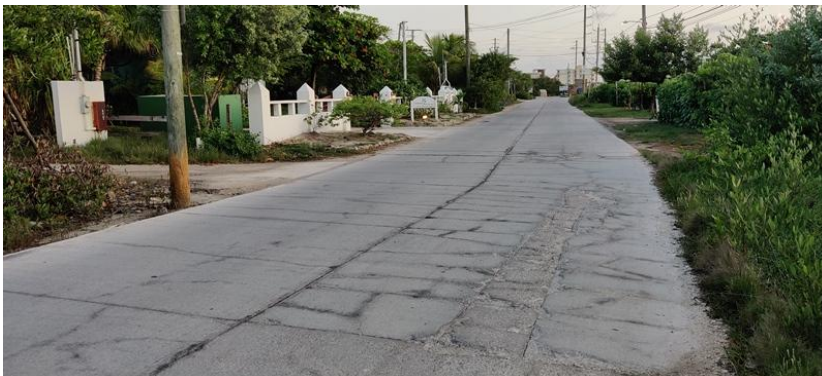
Area 13: Severity - 4

Location - North of Cocotal Inn.

Problem - Broken Road forces traffic to drive on the wrong side.

Recommendation - Replace road sections.

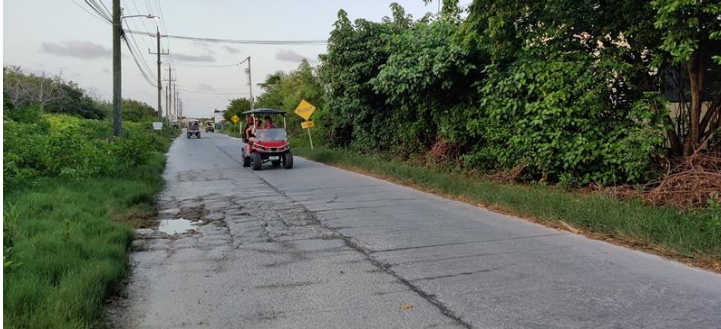
Area 14: Severity - 4

Location - South of El Pescador.

Problem - Forces 2 wheel and 4 wheeled traffic into the wrong side of the road.

Recommendation - Replace road sections.

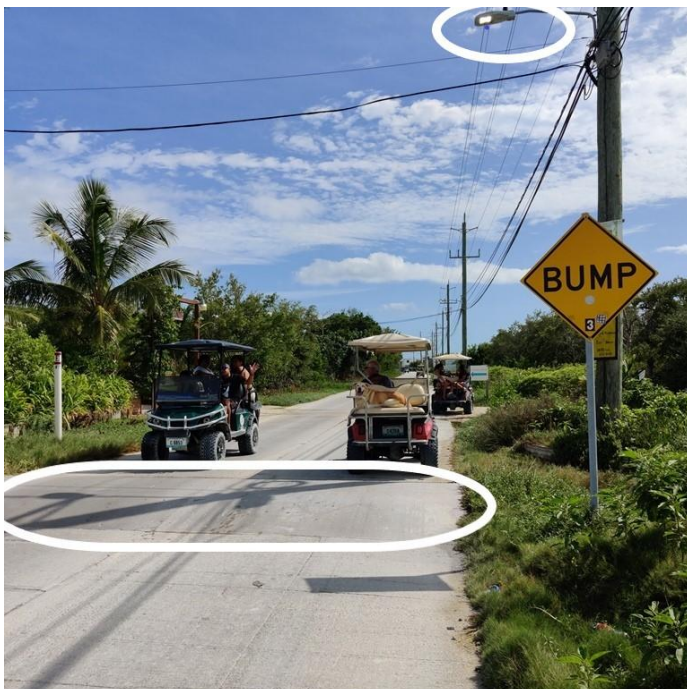
Area 15: Severity - 1

Location - South end of El Pescador

Problem - Speed hump needs more visible markings.

Recommendation - Decent quality hump, needs lighted signs.

Paint bump with yellow markings or stain the concrete reflectors.

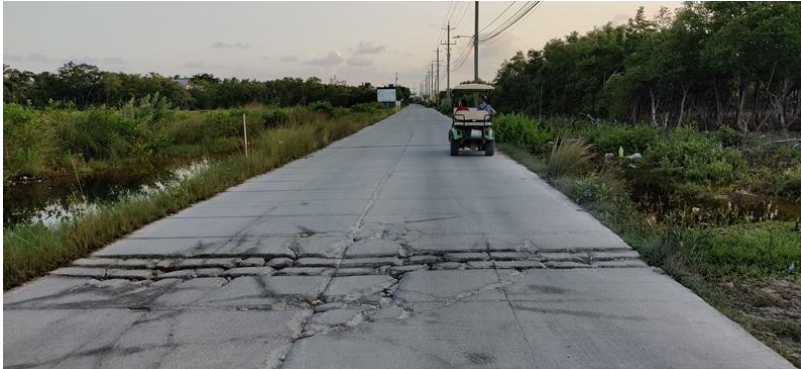
Area 16: Severity - 4

Location - El Pescador area.

Problem - Damaged road near Capricorn Restaurant.

Recommendation - Replace road section.

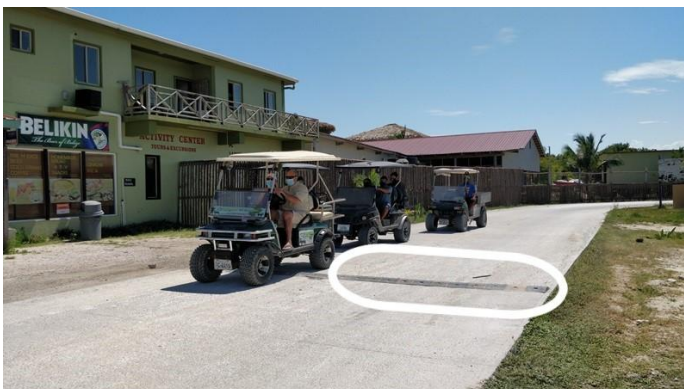
Area 17: Severity - 3

Location - Captain Morgan's north.

Problem - Wrong kind of speed bump design, no light, no signage. Replace.

Recommendation - Crosswalk style speed bump with standardised signage and lighting.

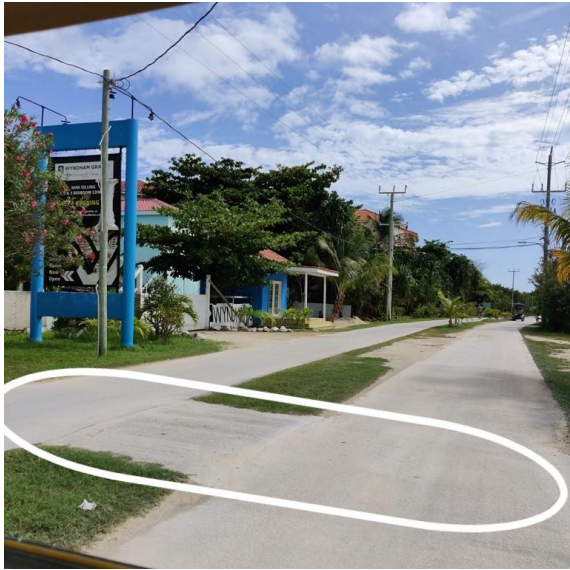
Area 18: Severity - 1

Location - Wyndham Grand.

Problem - Model speed calming hump 4 inches high 4 ft wide 24-inch ramps. (Flat top like Island City preferred model over rounded top.)

Recommendation - Needs marking and lighting as possible.

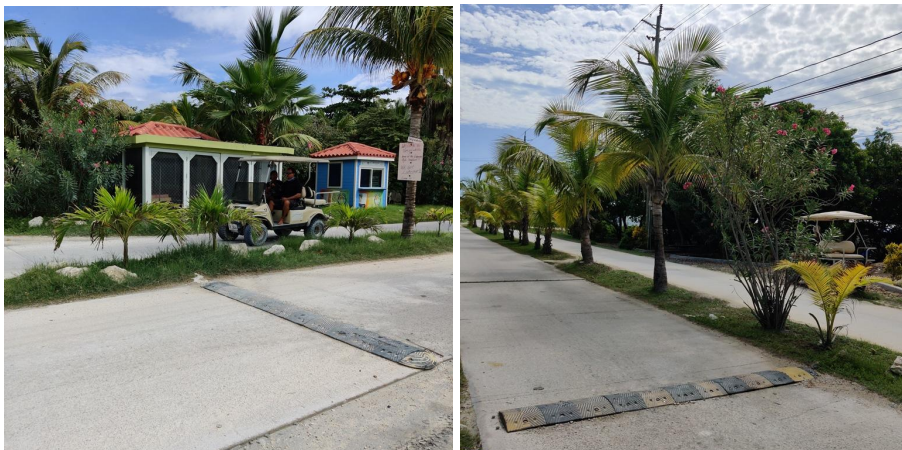
Area 19: Severity - 3

Location - Topsy Lobster close to Belizean Shores

Problem - Two hazard bumps need to be safer, crosswalk-style ones. No lights, poorly visible.

Recommendation - Replace with correct hump and markings.
